INSPECTION METHOD IN BAMBOO ROOFS: ASSESSMENT OF THE CONSERVATION CONDITIONS BY USING A DRONE AND SENSORY ANALYSIS

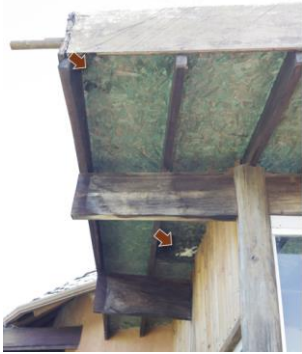
In the green roof system of the multipurpose hall (Figures 13 and 14) the points with the highest amounts of mold are caused by the drained water in the region of the gutters. In this system, anomalies related to lack of maintenance and errors in project execution were found.

<p data-bbox="233 1272 839 1339">Figure 13 - Infiltration caused by the accumulation of water present in the Multipurpose Hall building</p>	<p data-bbox="903 1084 1062 1158">F-1 Moisture patches</p>	<p data-bbox="1123 1068 1378 1173">4 – Actions requiring corrective maintenance</p>

The ceiling system whose material is OSB needs corrective maintenance, being characterized by level 4 of damage. Therefore, the action to be taken depends primarily on the repair of the upper system that has caused this type of anomalies, due to the presence of humidity and the detachment of the OSB lining. The identification of these manifestations is just an initial warning that deserves to be quickly dealt with, otherwise, it represents a danger for users.
